NASA-TM-X-2823C-1

EVALUATION OF REUSABLE SURFACE INSULATION
FOR SPACE SHUTTLE OVER A RANGE OF HEAT-TRANSFER RATE
AND SURFACE TEMPERATURE

By Andrew J. Chapman
Langley Research Center

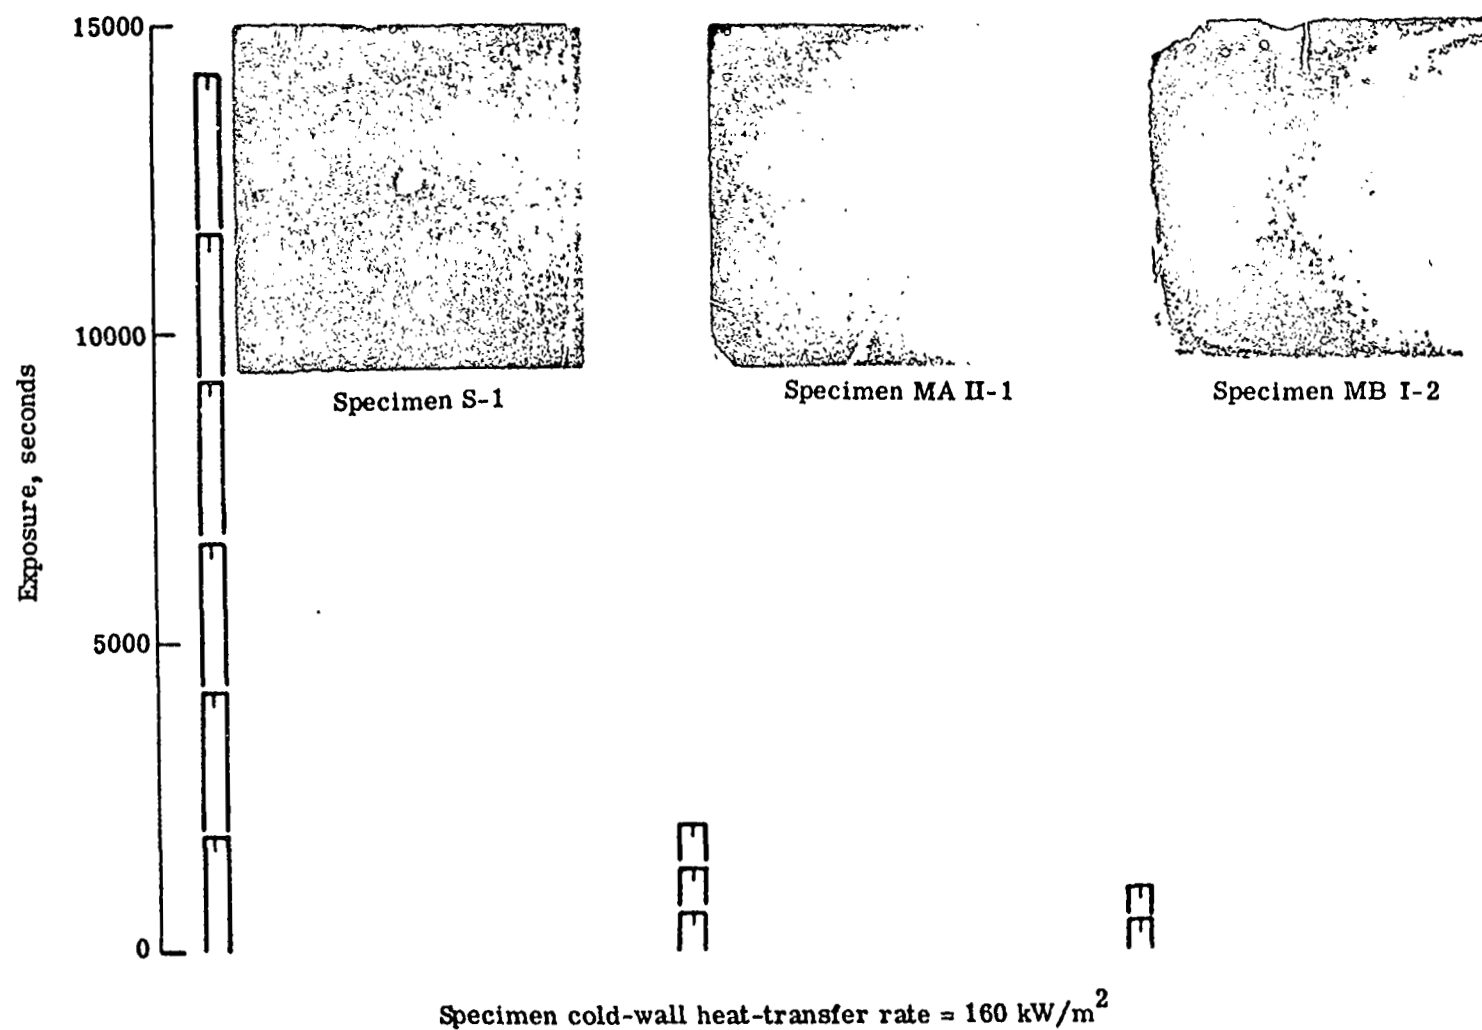
Figure 5.- Cumulative exposure time and specimen condition after testing at nominal shuttle entry conditions.
Specimen size, 13 cm square; test stream direction from right to left.

The results of testing three materials at test condition 1, nominal shuttle entry condition, are shown in figure 5. The heating rate of this test condition corresponds closely to the shuttle peak area 2 heating shown in figure 4, although the tests were more severe than shuttle entry because of the abrupt heat-up and cool-down. As noted previously, the 13-cm-square specimens were not coated on the sides and did not have a surface thermocouple.

Silica specimen S-1 accumulated 14 216 seconds exposure during six consecutive tests. After this test series, the coating did not appear to be degraded; however, there was a microscopic crack in the surface through which water penetrated. Mullite specimen MA II-1 accumulated only 2036 seconds exposure during three consecutive tests, after which the forward area of the coating was discolored, covered with small blisters, and penetrated by a large crack. Mullite specimen MB I-2 accumulated only 1049 seconds exposure during two tests after which the entire surface was degraded and pitted and the forward edge was glazed as a result of melting.

At test condition 1, the silica material survived with minimal degradation, whereas the mullite coatings not only cracked but showed evidence of incipient melting as well. Further, total exposure time for the silica was more than seven times greater than for the mullite materials.

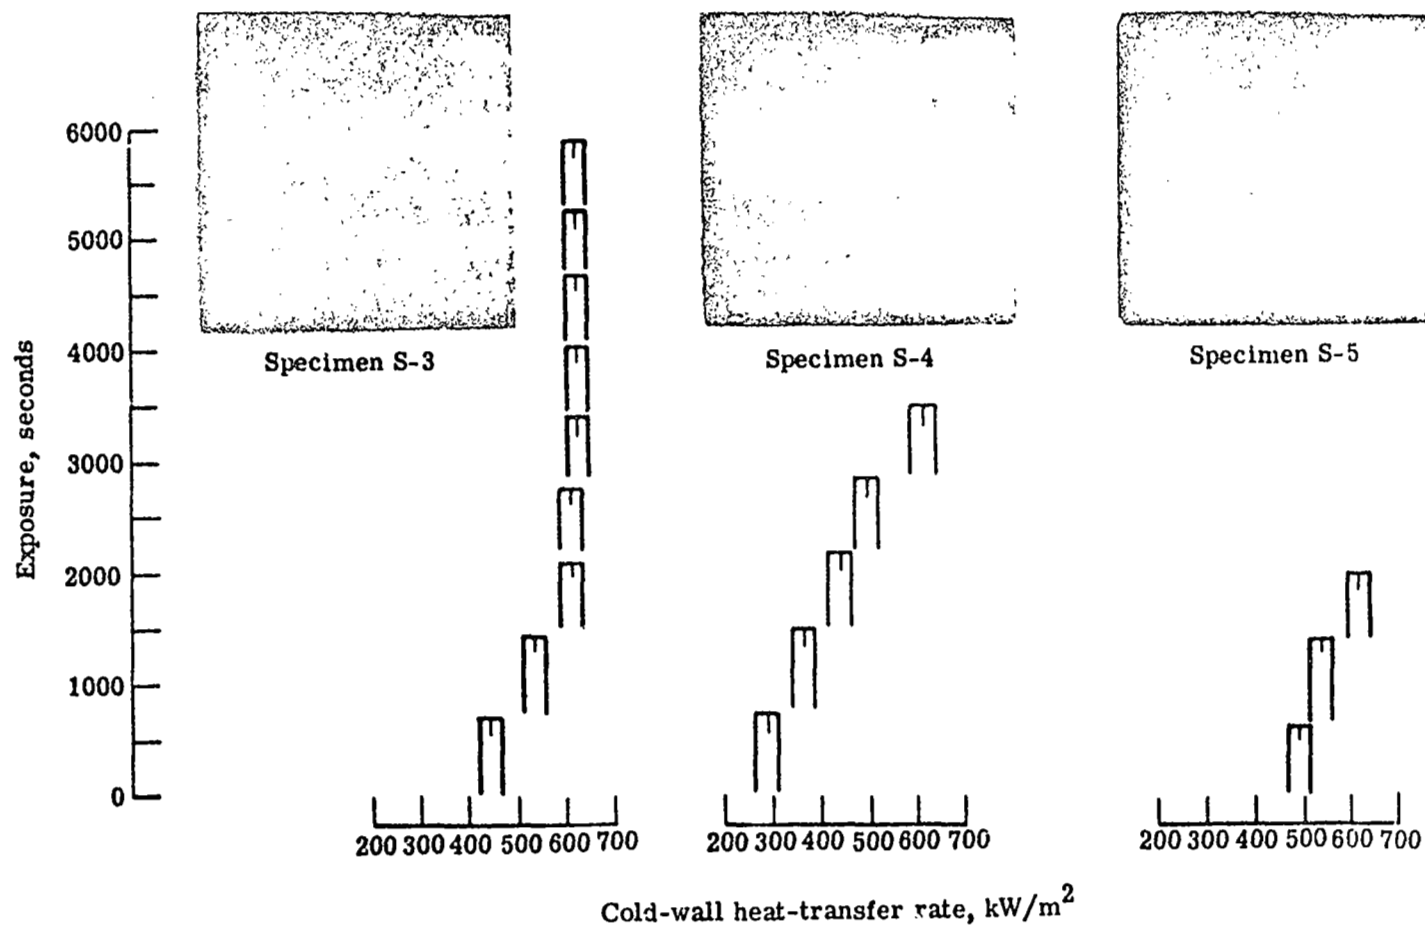
(a) Material S.

Silica material S.- Results of testing 9-cm-square specimens of material S at increasingly severe conditions are shown in figure 6(a). Specimen S-3, which was not coated on the sides and did not have a surface thermocouple, accumulated 5900 seconds exposure during nine tests. Seven of these tests represented 4470 seconds exposure at the more severe test conditions. At the end of this series of tests, the forward surface, which experienced the highest heating rates, was a somewhat lighter color than the original and was slightly warped but was otherwise undamaged. There were no visible cracks, and water did not penetrate the surface during observation.

Specimen S-4 was tested through five cycles of progressively severe test conditions through test condition 7. After this test series, the forward one-third of the surface area was slightly discolored and covered with small, granular protuberances which are believed to be evidence of incipient melting. Thin cracks through the coating extended from the surface thermocouple forward and aft. Water was not observed to penetrate through these cracks. The side coatings had no visible cracks.

Specimen S-5 was tested through three cycles beginning at test condition 5 to identify the condition where melting would begin. After the test at condition 6, the fine granular protuberances were again observed on the forward part of the top surface. These protuberances were more pronounced after testing at test condition 7, and cracks extended from the surface thermocouple. Cracks were not visible on the side. Water penetrated the coating in the vicinity of the surface thermocouple and through the cracks.

Changes, which were probably incipient melting, in the material S coating began to appear during tests at cold-wall heating rates of 530 kW/m^2 and surface temperatures of 1670 to 1700 K. However, these changes did not progress to become serious degradation,

and one specimen of material S repeatedly survived surface temperatures as high as 1850 K with only gradual and moderate changes. The only coating cracks originated where thermocouples were embedded in the coating or occurred on 13-cm specimens which experience higher thermal stresses than the smaller 9-cm specimens. Cracks were not observed in side coatings or near corners where stress concentrations are high.

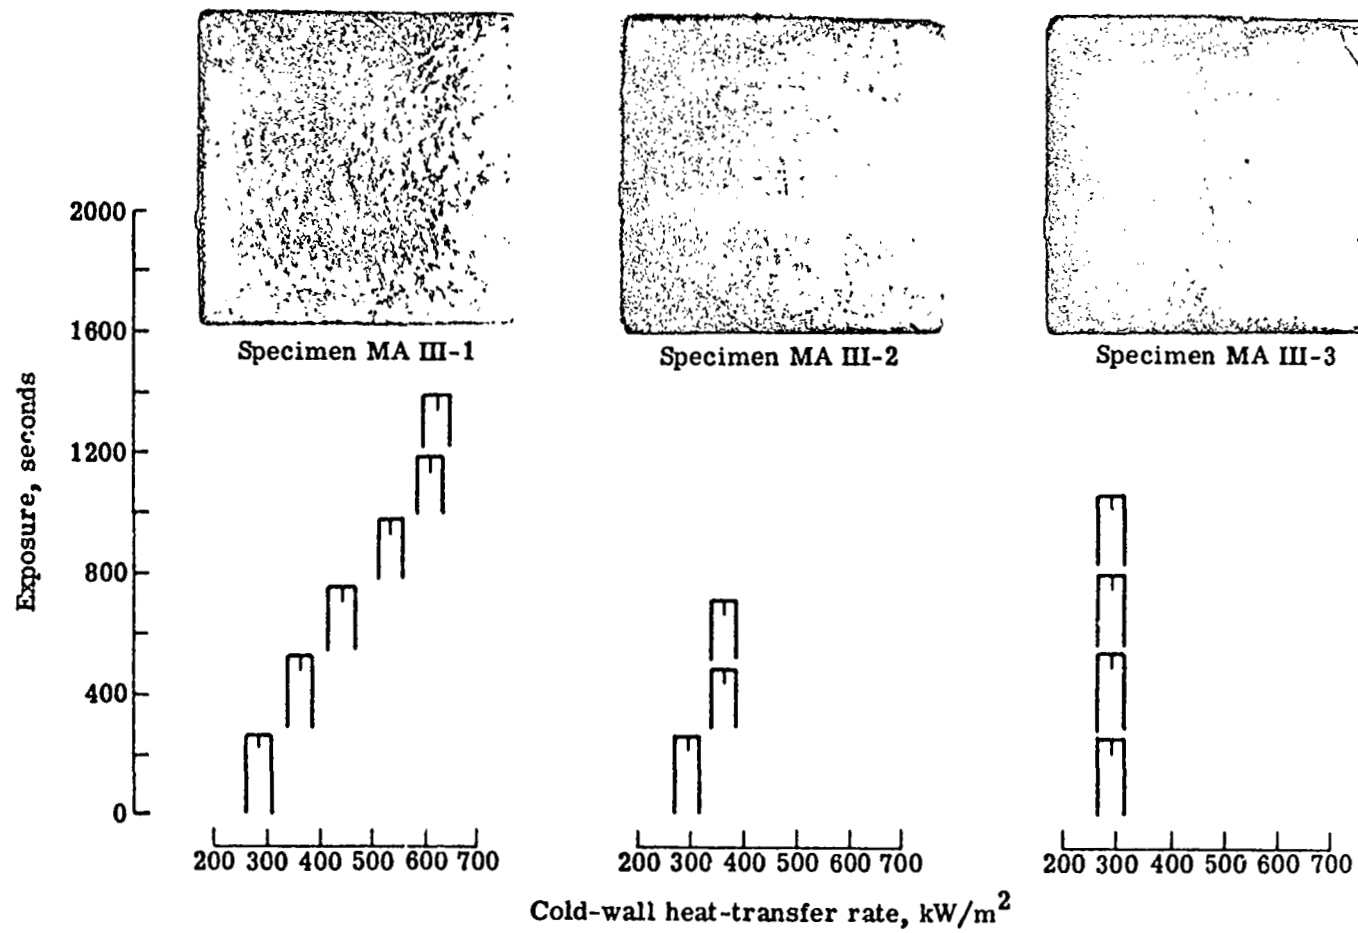
(b) Material MA III.

Mullite material MA.- Results of testing 9-cm-square specimens of material MA III at increasingly severe conditions are shown in figure 6(b). Specimen MA III-1 was exposed for 1389 seconds during six tests. At the end of the fourth test (condition 6), the forward area of the top surface was cracked, discolored, and uneven as a result of melting. The average surface temperature at test condition 6 was 1600 K. At the end of six tests, the last at test condition 9, more than three-fourths of the top surface was rippled and uneven and the forward one-third of the surface was extensively glazed. The coating was penetrated by a wide crack on the forward half of the top surface and was also cracked along the forward side and around the forward corners. Water penetrated the cracked areas of the coating. The average surface temperature at test condition 9 was 1750 K.

Specimen MA III-2 was tested beginning at test condition 2 to establish the conditions which initiated serious degradation in this material. This specimen survived one test at test condition 2 without noticeable degradation. After two tests at condition 3, the forward one-third of the surface was somewhat lighter than the original color and had a granular texture. The coating was cracked extensively on the top surface and on the forward side extending around a forward corner. Water penetrated the coating at some large cracks and at other points where cracks were not clearly visible. Average surface temperature at test condition 3 was about 1500 K.

Since specimen MA III-2 did not survive test condition 3, specimen MA III-3 was tested through four cycles at test condition 2 to determine whether the material would survive the less severe test condition. Some granular texture was observed on the forward surface at the end of the first test. The cold-wall heating rate was 40 percent higher at the forward edge of the specimen than at the center, and during subsequent tests of specimen MA III-3 at condition 2, the radiometer was focused on the forward edge of the specimen to measure temperatures at the higher heating rate areas where degradation was occurring. These temperatures measured along the forward one-fourth of the surface were between 1480 and 1510 K as compared with 1410 K at the center. Following the fourth test cycle of specimen MA III-3, the forward one-third of the surface had the granular texture and lighter color noted previously. The top surface was cracked from the thermocouple to the forward edge and on one corner, and the cracks on the forward side extended to the corners. Water penetrated the surface at the cracks and at the surface thermocouple locations. These results show that material MA III was unable to withstand repeated testing at conditions corresponding to shuttle area 2P peak heating.

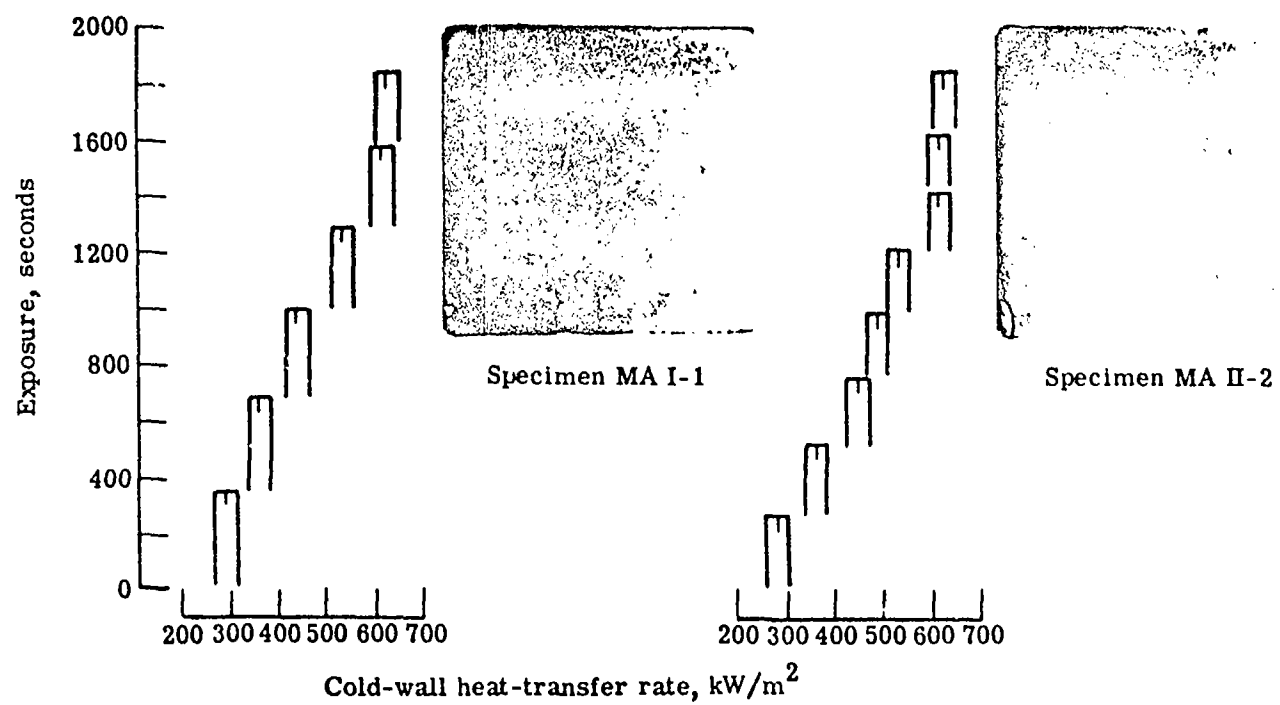
(c) Materials MA I and MA II.

Results of testing 9-cm-square specimens of materials MA I and MA II are shown in figure 6(c). Both specimens were tested through repeated cycles ending with the most severe test condition, and both specimens were tested for a total time of approximately 1850 seconds, although the tests of MA I-1 consisted of six cycles whereas the tests of MA II-1 consisted of eight cycles of somewhat shorter duration.

The coating of specimen MA I-1 was discolored but only moderately glazed. Otherwise the coating appeared less degraded than that of the other MA materials. Specimen MA I-1 was, however, cracked on the forward side, and this crack extended to the top surface at a forward corner. Water penetrated the coating at this crack and near the surface thermocouple.

Specimen MA II-2 was not coated on the sides and did not have a thermocouple in the top surface. At the end of the test series, the top surface was extensively glazed and discolored; however, the surface was not visibly cracked and water penetration was not observed.

There was a wide variation of performance among the mullite MA materials. Material MA I, which performed best, cracked only at the high stress concentration area on the specimen forward side near a corner and experienced only incipient melting during repeated tests which included the most severe conditions. However, material MA I accumulated less than one-third the total exposure accumulated by silica material S which survived the test series with minimal degradation. Materials MA II and MA III, which were developed later than MA I, experienced cracking and incipient melting at the lower test conditions, which are within the range predicted for shuttle entry, and experienced extensive and severe melting during tests at the highest conditions. In addition, the MA materials were markedly less efficient insulators than material S. During individual tests at comparable conditions and specimen unit weights, exposure periods for a back surface temperature rise of 167 K were greater by a factor of 2 for material S than for material MA.

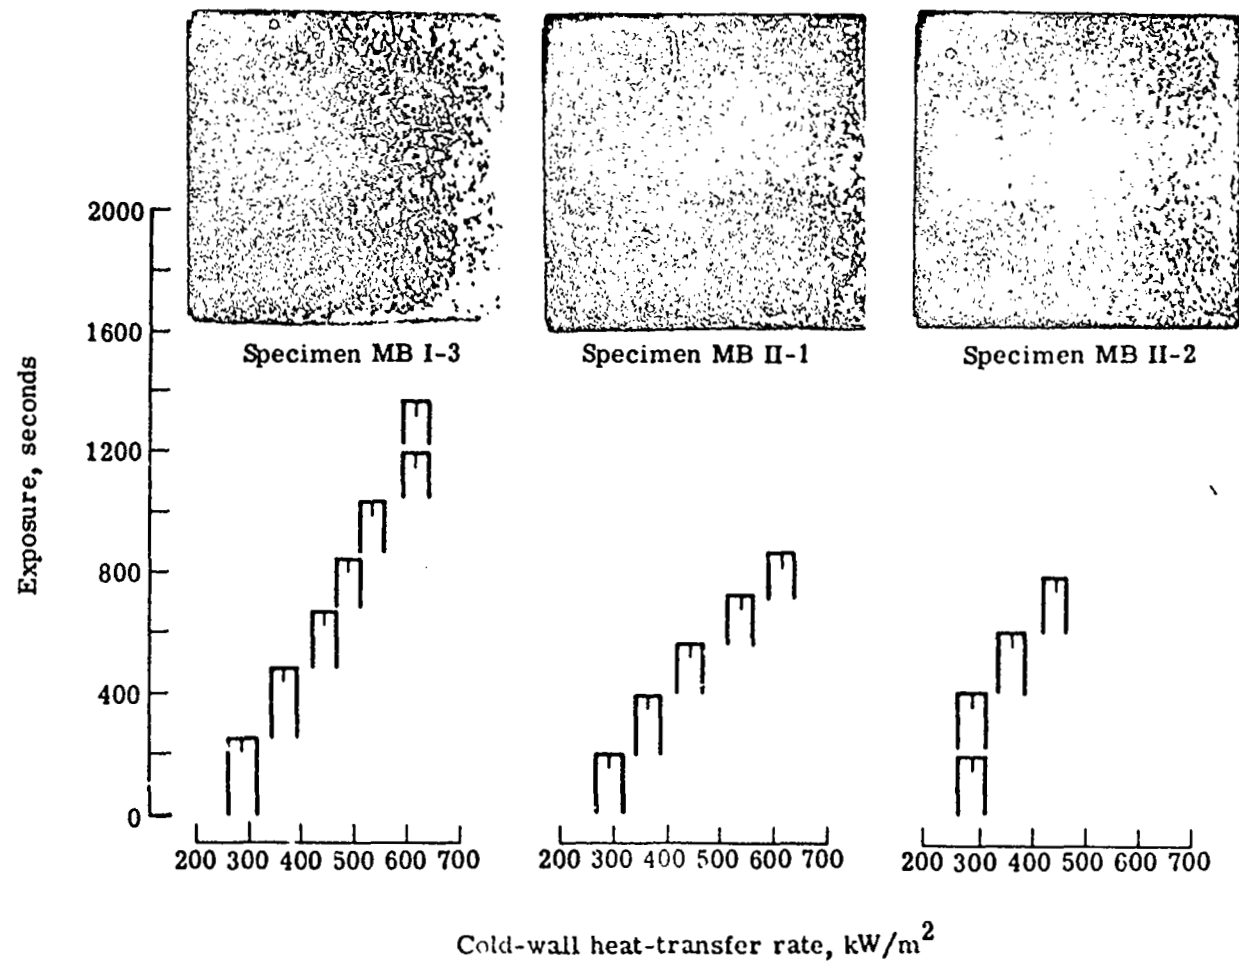
(d) Material MB.

Mullite material MB.- Results of testing 9-cm-square specimens of material MB through increasingly severe conditions are shown in figure 6(d). Specimen MB I-3, which was coated only on the top surface, was tested seven times at seven different test conditions for a total exposure of 1372 seconds. After this testing, the entire surface was extensively glazed and pitted. Water penetrated the coating at many places.

Specimen MB II-1 which was coated on the sides as well as the top was tested five times, the final test being at test condition 7. After these tests, the forward two-thirds of the coating was glazed, pitted, and cracked. Cracks extended from the front side around the corners to the other sides and over the corners to the top surface. However, water penetrated the coating only at the surface thermocouple location.

Specimen MB II-2 was tested twice at test condition 2 before proceeding to conditions 3 and 4. After testing at condition 4, the surface was glazed and discolored; however, no cracks were visible. Water penetration of the coating was not observed.

Material MB surface temperatures were markedly higher over the range of test conditions than those of either material S or material MA. Coating degradation was extensive after relatively short tests at test condition 1, where surface temperatures were approximately 1800 K, and the coatings continued to deteriorate further through a series of tests up to test condition 7, where surface temperatures were approximately 1970 K.
